Manhole Inspection Summary

Manhole # S49W1_014MH

Location Address: **3214 Tate St.**

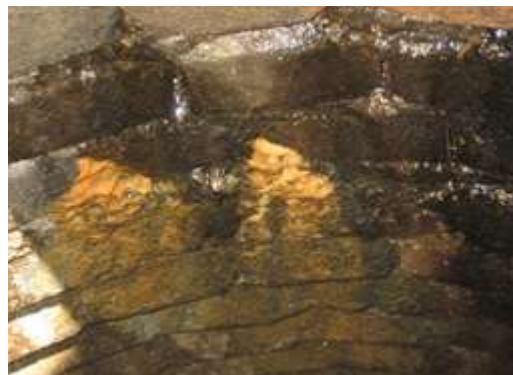
Defect 2

Condition: ☐ Sound ☒ **Cracked** ☐ Root Intrusion ☐ Loose Brick ☐ Deteriorated

Infiltration: ☐ None ☐ Joint ☒ **Cracks** ☐ Mortar ☐ Roots ☒ **Wall**

Crack and infiltration
